## WESTLAKE COTTAGES IN *THE GAP*

### **The Septic and Sewer System**

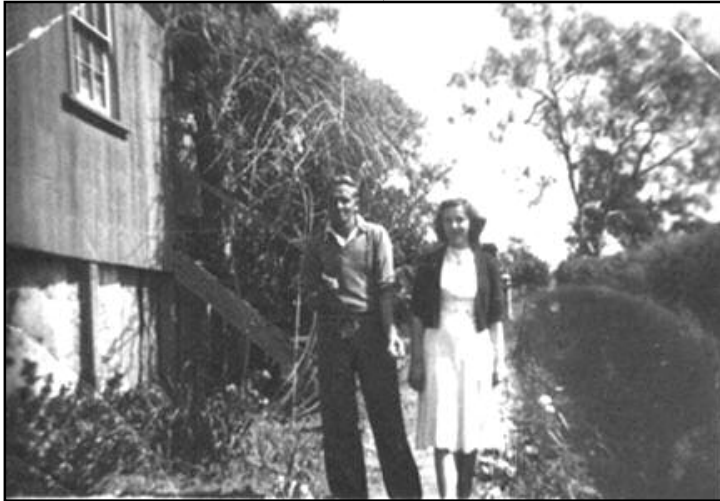
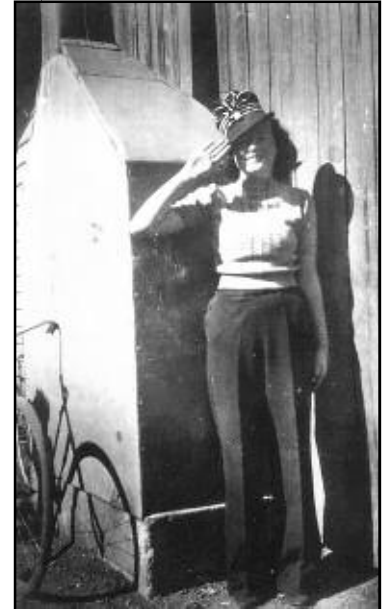
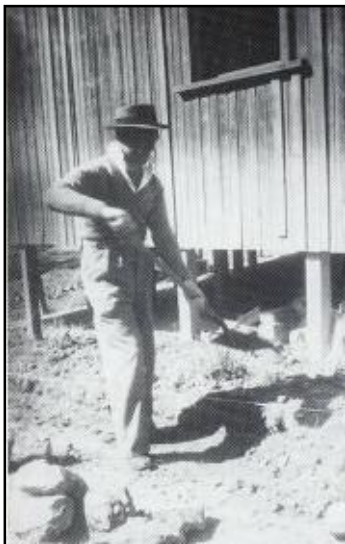
Top left photograph - Rhona Bourke and one of her brothers outside 1 Westlake. Below on the left is Tom Smith working on his garden 13 Westlake. Note the vertical timbers and the concrete piers. Above right is one of the O'Rourke girls near the green tin chimney of her home - 45 Westlake.

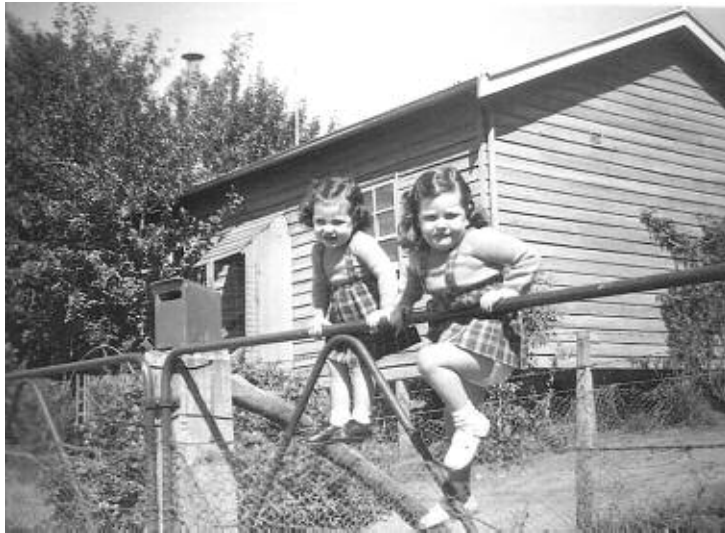
Below is a photograph of Helen & Diane Bates on the gate of 59 Westlake. In the background is 58 Westlake – a 1926 cottage. The structure at the front entrance was not part of the original structure and was probably erected by one of the tenants. Note that the timber cladding is horizontal not vertical. The cottages erected in 1925 (Causeway) and these cottages at Westlake in 1926 by the Federal Capital Commission placed the timbers horizontally. The ones built by the Federal Capital Advisory Committee (1923-24) at Westlake and Acton placed them vertically.

had left the area in 1925. These ten cottages had the same basic plan as the original cottage design but differed in that the combined laundry bathroom was built at the back of the kitchen instead of the bedroom. The newer buildings, like the 120 built at Causeway in 1925 and 1926, had the exterior timber planks nailed horizontally instead of vertically.

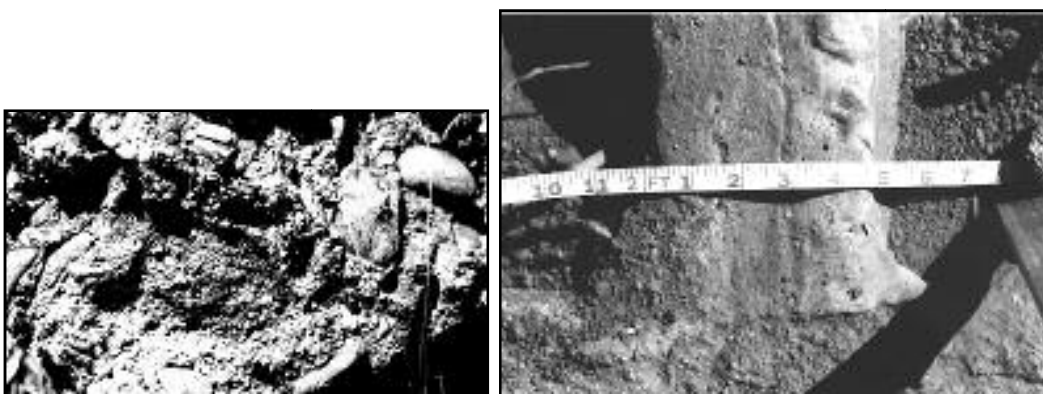
Below left detail of concrete wall showing river rocks used in the concrete. On the right is a detail of lead lining still in situ.

That this structure is a temporary is evidenced by the variations in measurements and the lack of finish. If this tank was permanent one would expect the length to be 12ft not 11. In parts the wall is 7 inches thick instead of 8 and so on. The concrete work has not been finished and in it exposed are large river rocks. In one corner is what may have been an inspection hole where corrugated iron was used as a cover. It left its imprint in the concrete. Still in situ is a lead lining over the middle wall of the tank.
