The Ablutions Area Tradesmen's Camp Westlake Study Area 2003

The Tradesmen's Camp was established in early 1924 on the eastern side of the quagmire on the hillside opposite modern Lotus Bay. It was removed in late 1927.

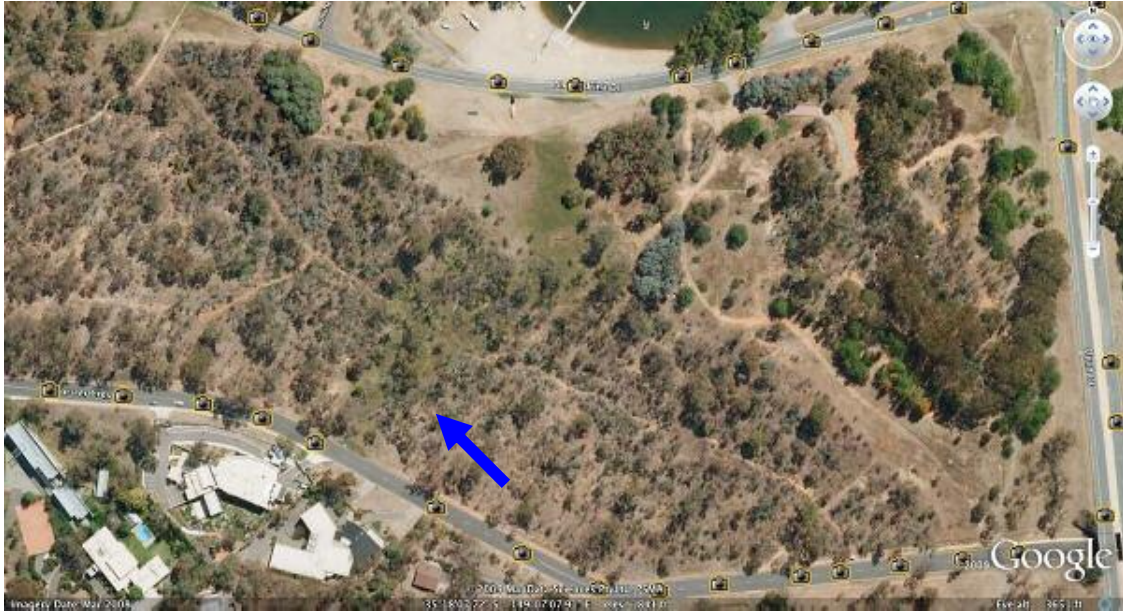
Above – aerial view (2009) of East Stirling Park. The blue arrow points to the general area of the ablution's area and it stretches between the modern road of Forster Crescent down to the old road that cuts across the hill. The original camp extended over into the area of the embassies in Forster Crescent.

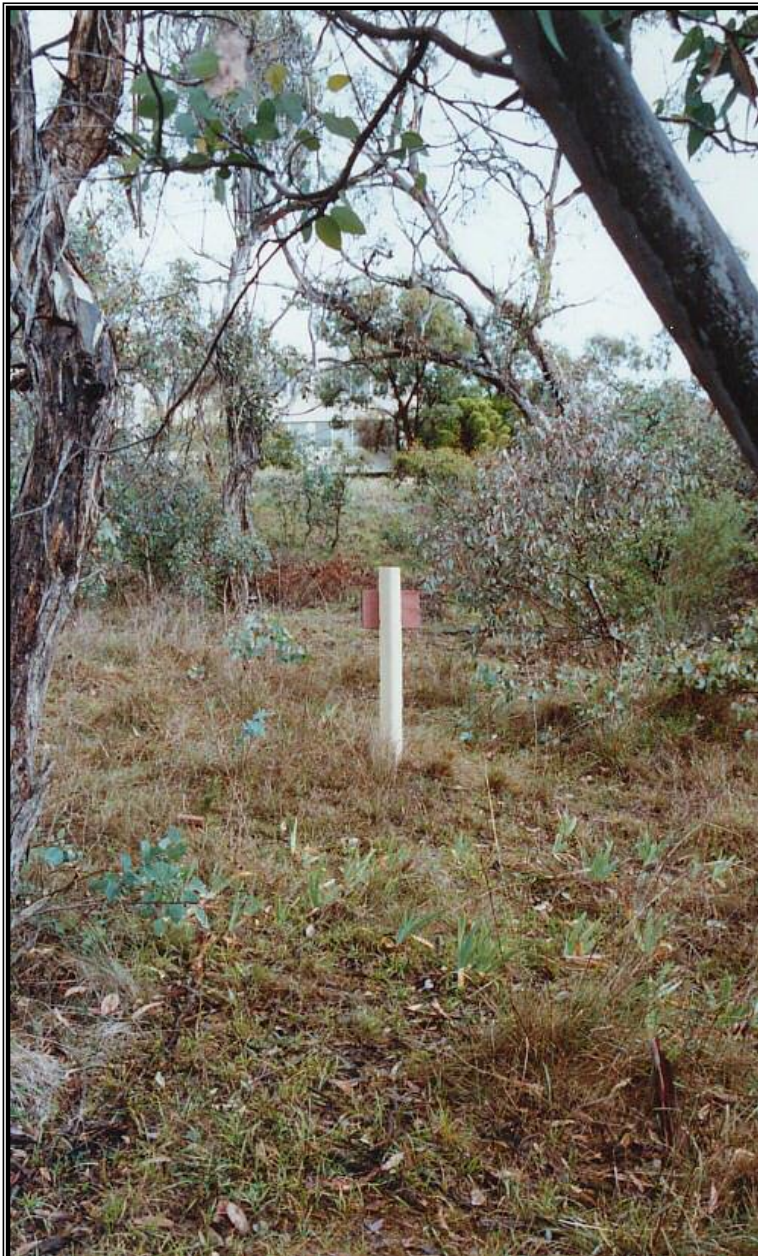
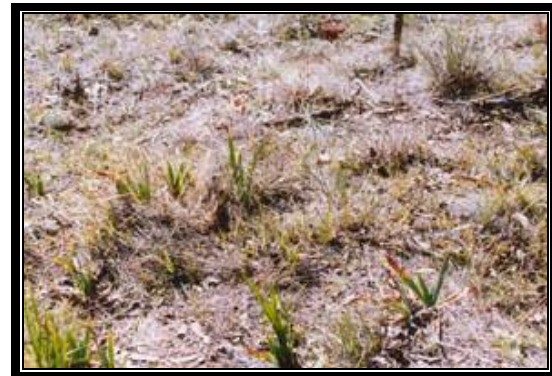
Area of Rubble at Top of Hill

Above left general view from the area where the levels commenced up to Forster Crescent and the Brazilian Embassy. Off to the right in this photograph that shows the white iris plants are the bricks and rubble. On the right is a detail of the flowers in August 2003.

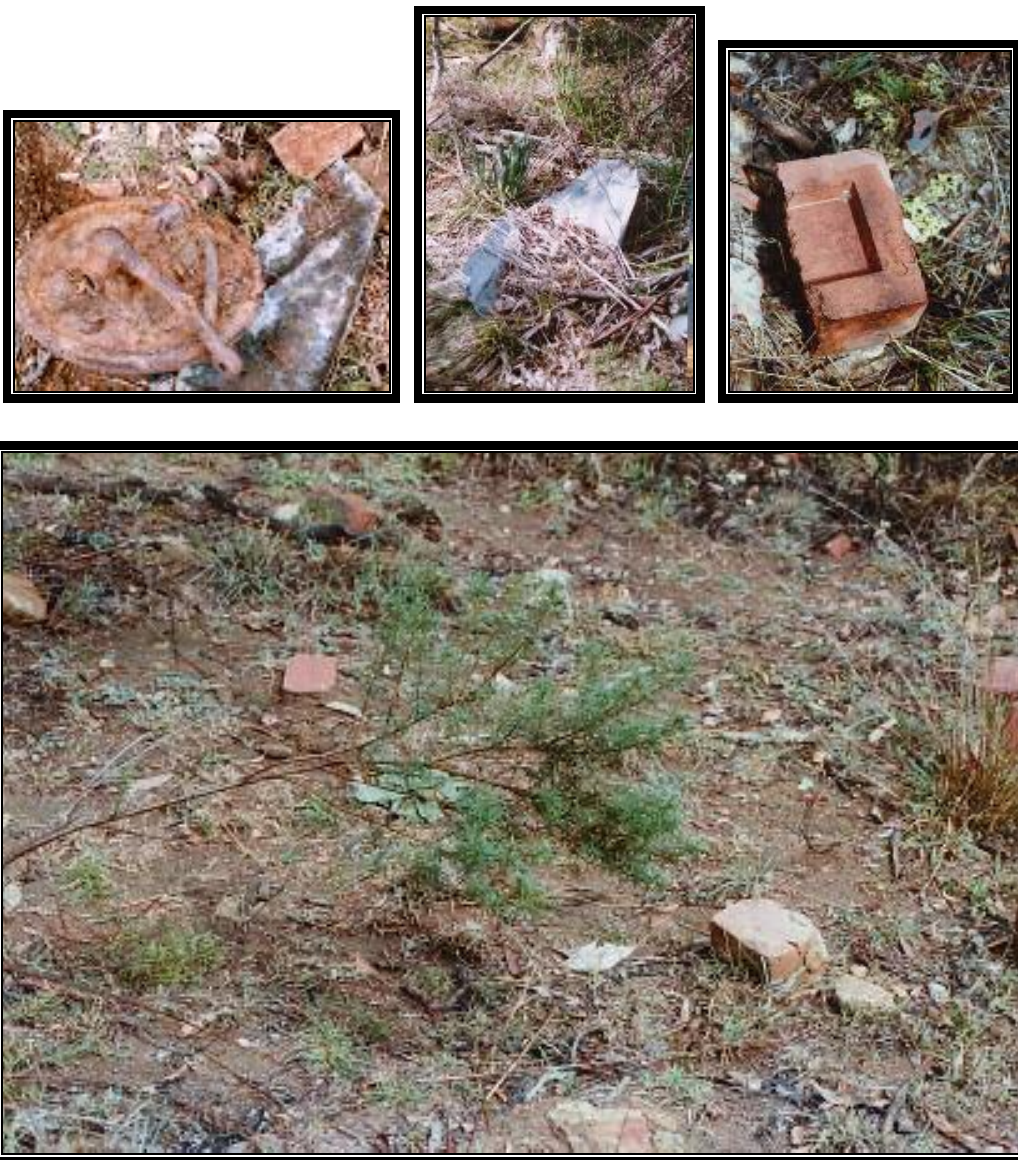
Above examples of the brick rubble still in situ. Since the photograph was taken the soil has been brushed back to reveal other bricks that form part of an undulating pattern.

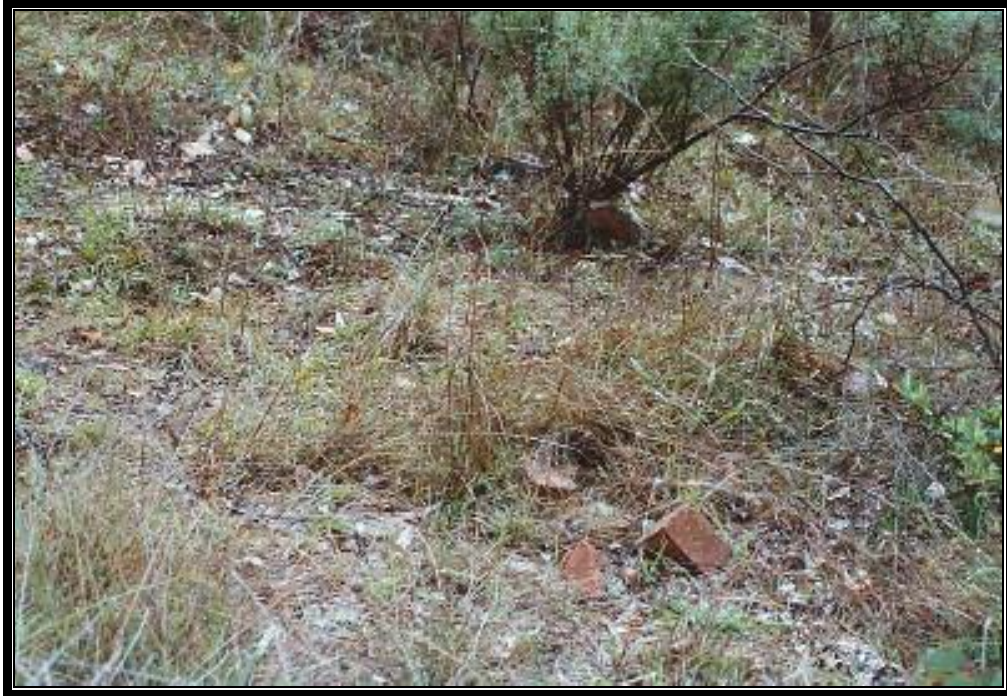
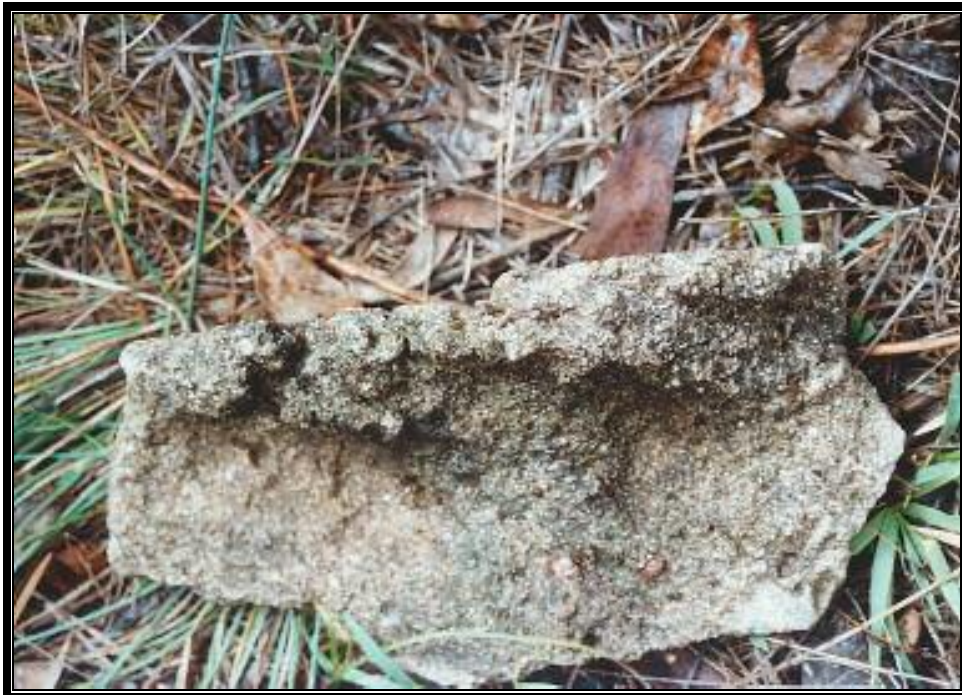
Below are two sections of concrete path below the large pile of earth. This may be the remains of a section of path laid near the entrance to the building. One of the buildings in the lower section of the hill complex has small stones laid at an entrance - the concrete and stones may have served the same purpose of reinforcing a well used entrance area.

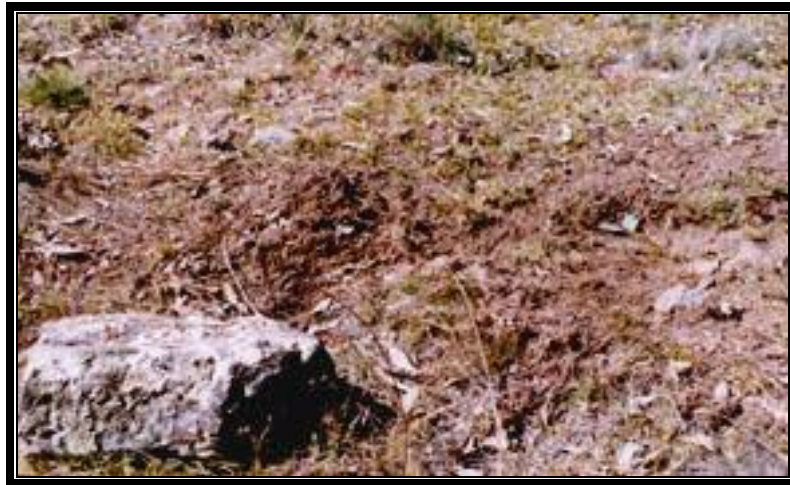
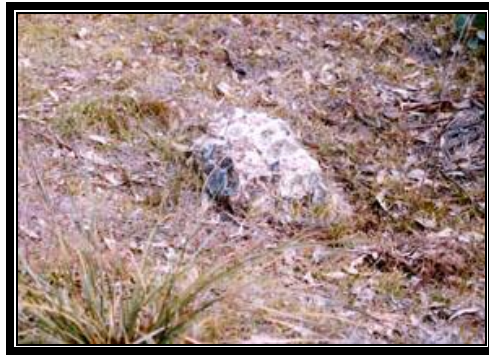
Stormwater was slowed on its way to the quagmire by the undulating brick patterns. Earth near two large rocks has been dug away and water directed to these areas. Above one the earth has been reinforced on two sides with small rocks. The purpose of the rocks is to slow down water flow. Below are two photographs taken of the smaller of the two rocks. The left hand photograph shows a drain exit and on the right the lighter areas around the rock is the area where the small stones have been placed to stop erosion of the soil.

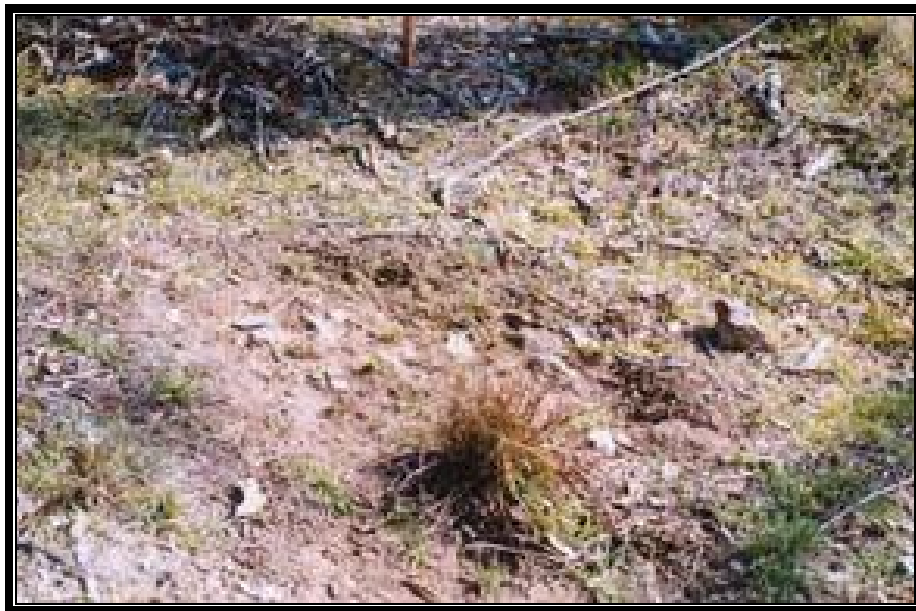
Below - detail of the rocks on either side of the big rock hole. Since this photograph was taken heavy falls of rain have taken place. The stones that include a number of bricks have been further exposed indicating that this area has a strong storm water flow and are still doing their job of stopping erosion.

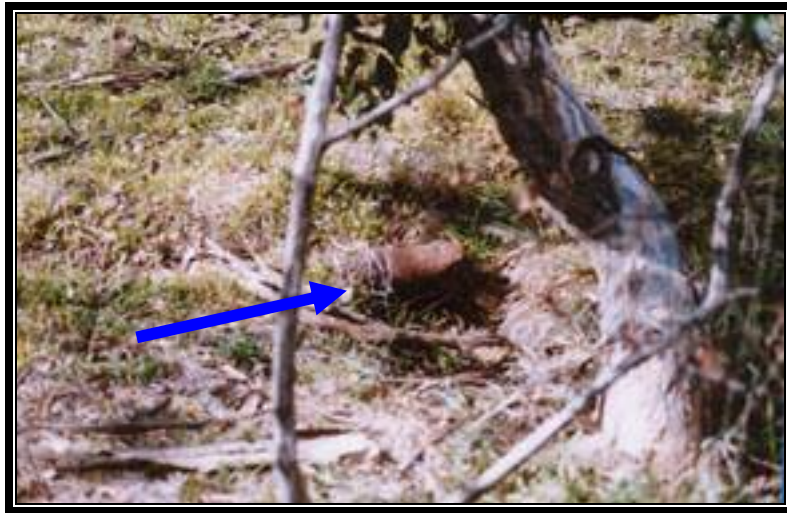
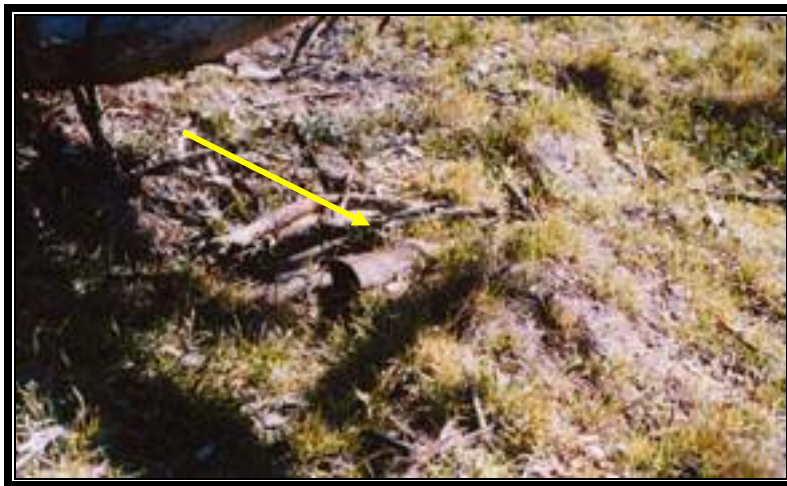
Near one building site is a large metal pipe set into the ground. This too may have served to take water from a building to direct via connecting drain to the quagmire. At the point of exit of water from the pipe a small marble (or codd) was found along with a few pieces of broken white crockery. Below are details of the metal pipe prior to clearing away grass near the exit of the pipe.

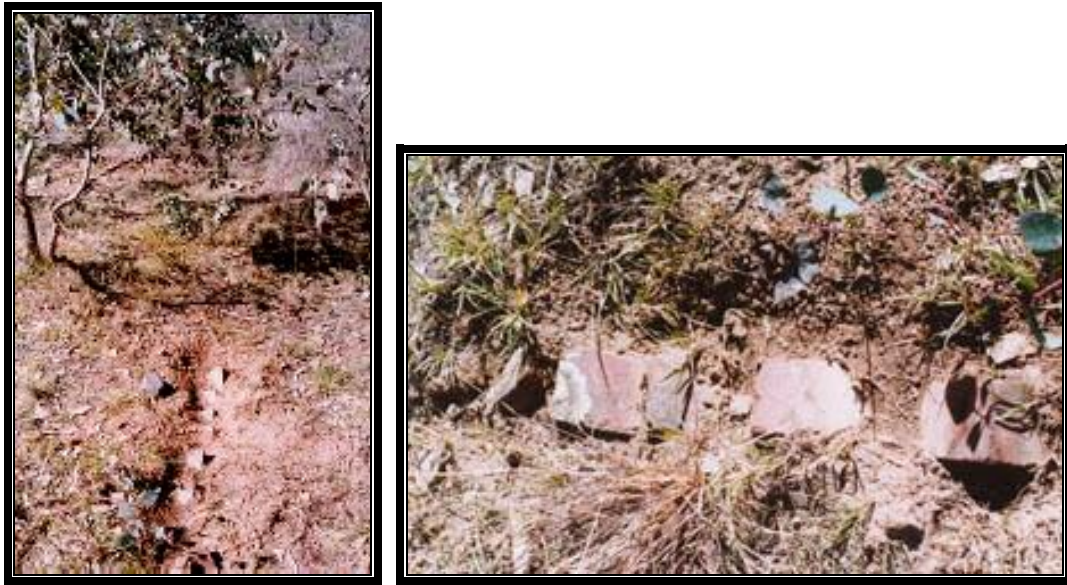
Between this building site and one of the large rocks that has had earth dug away from it on the upper side of the slope there is another brick line of rocks. These differ from the rubble ones in that they have been cleaned and set into the ground diagonally. The bricks slow the water, but the space between allows some to flow through. This hillside contains a system of slowing water flow from source to quagmire. Nearby to the brick pattern is one of the rock lines that serve a similar purpose. Below are photographs of the brick line.

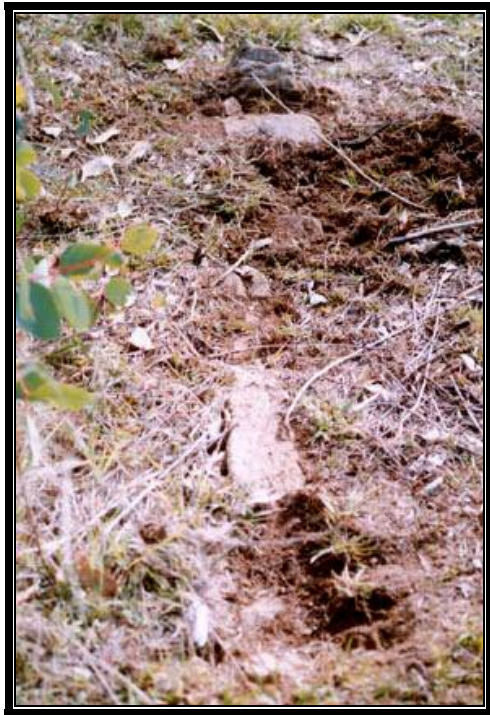
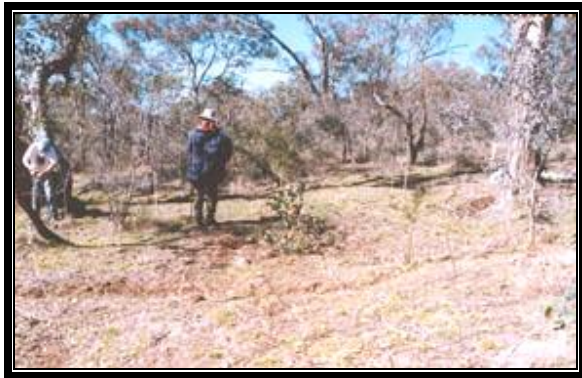
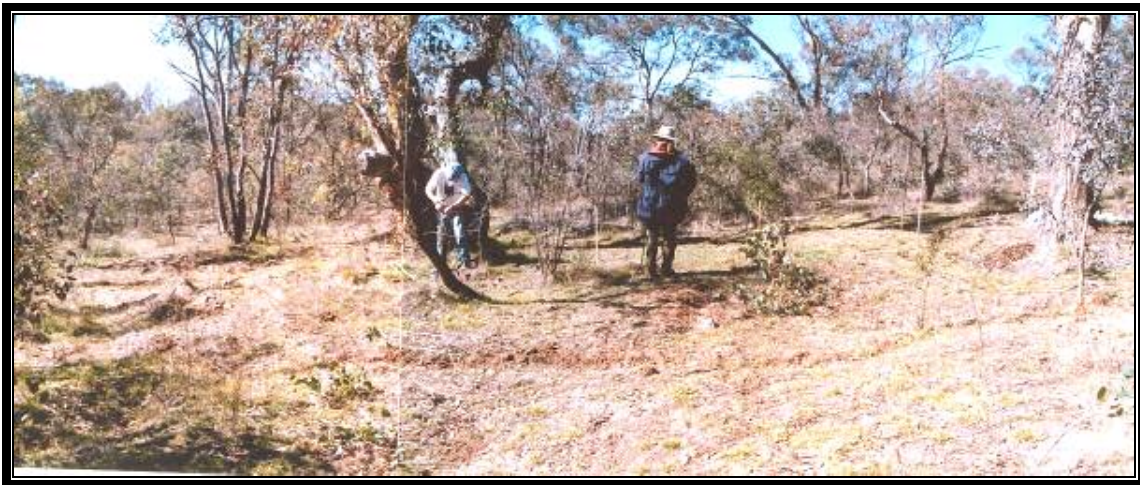
Below are photographs that show the line of bricks and stones below the terraced area.

Above - two photographs joined to give panoramic view of the tree near the trench (left), terraces, line of bricks and in front of the smaller group of trees on the right the bank of earth with undulating line of rocks. Karen Williams and John Bruggeman measuring the drop in the land.

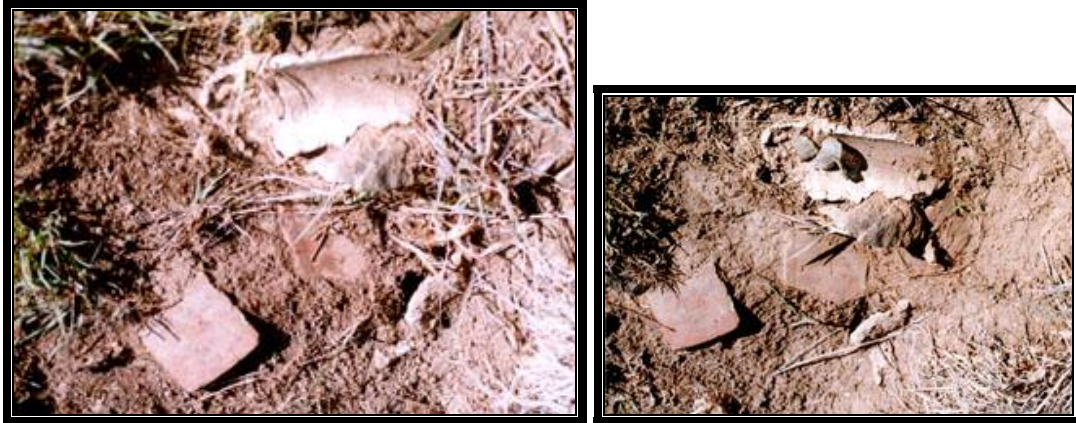
Between the area of John Bruggeman the small tree in the foreground is another drain that continues down to join the circular stone arrangement that included an upsidedown saucepan.

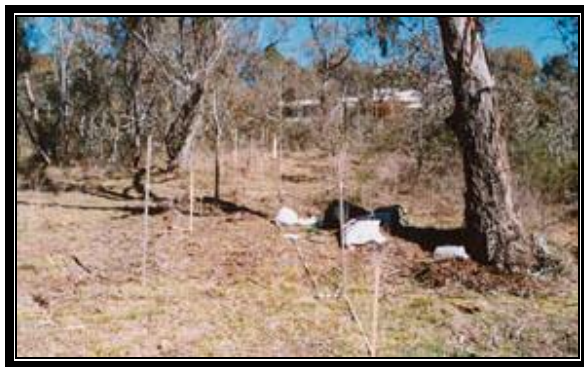
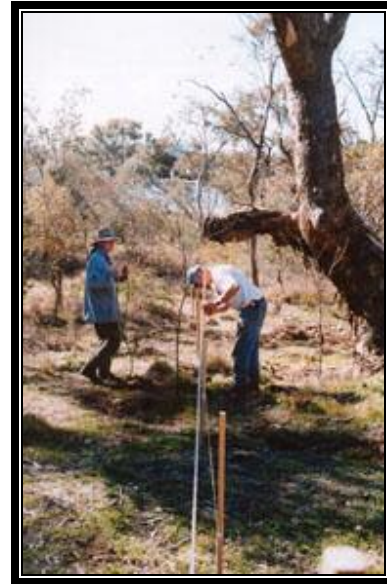
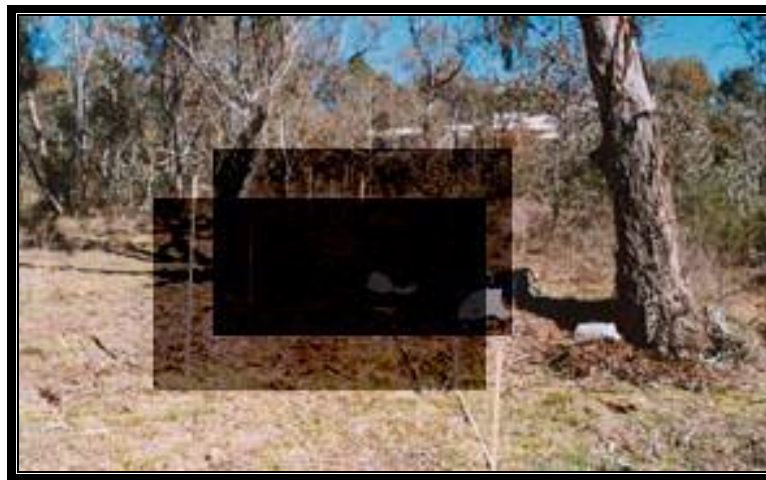
Below left - terraced beds, trench area (bags sitting on terrace) - looking up the hill towards Forster Crescent. Below right, looking down the hill from the terraced area to road. Karen Williams and John Bruggeman measuring.

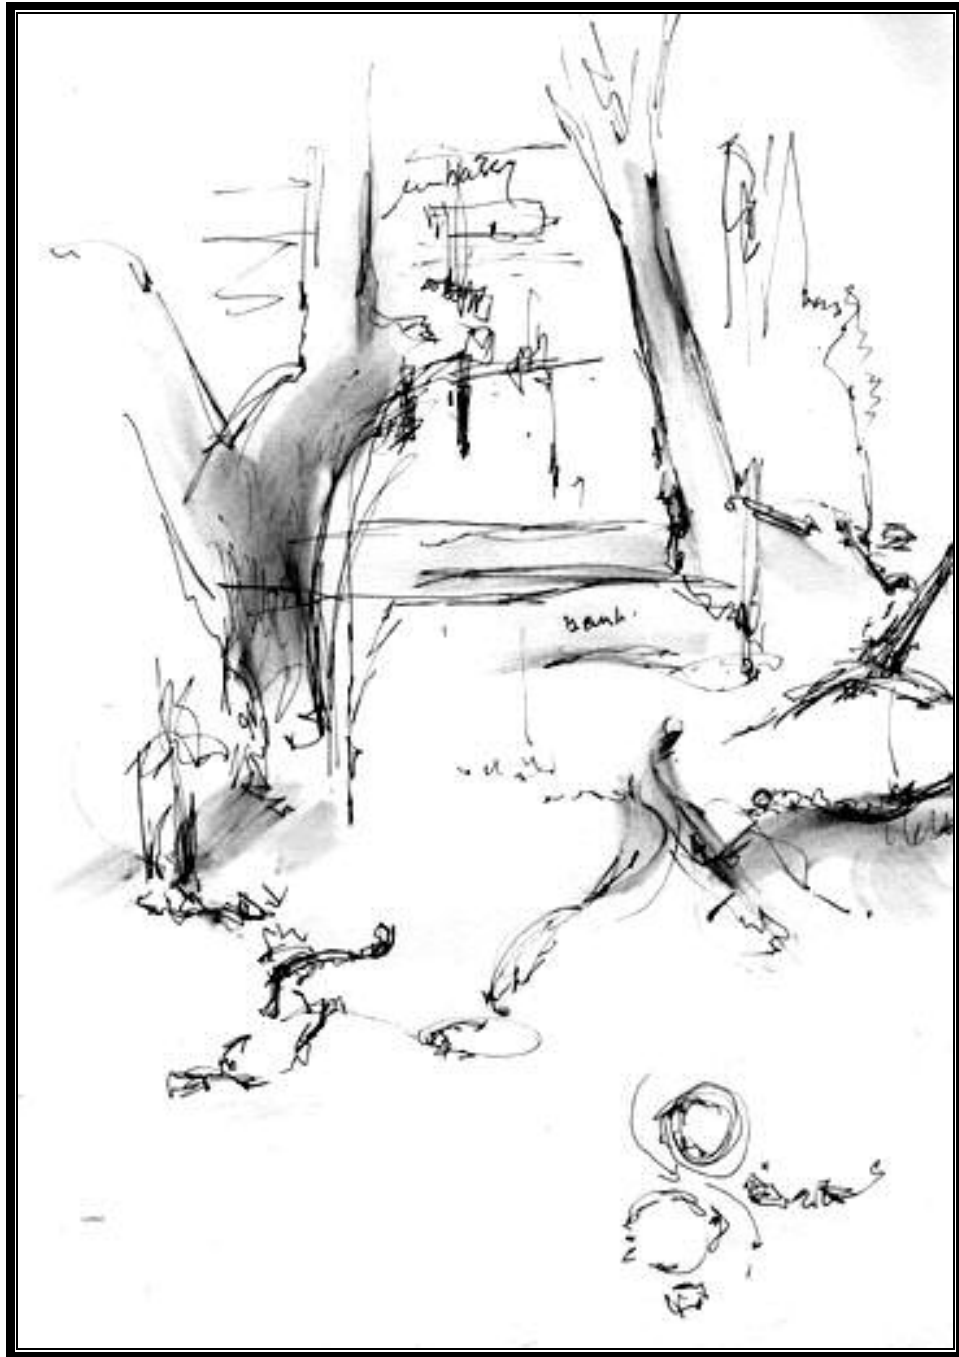
Two old gum trees were left on the site of the Ablutions Blocks. Both have branches trimmed. The first sits just below the trench on the quagmire side and the second above the garden area. Below is a sketch of the area from the old road looking up the hill. The rubble section is above the tree on the right. The mid section between the two trees and the gardens below the lower tree and the road.

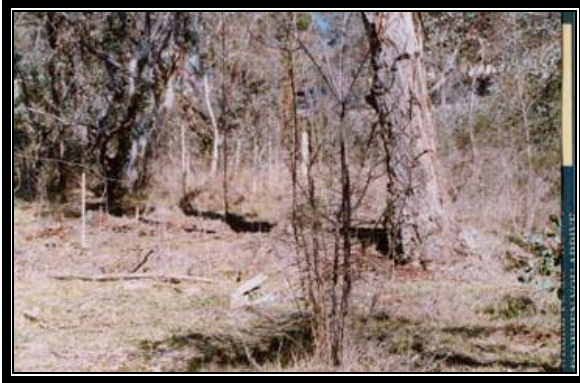
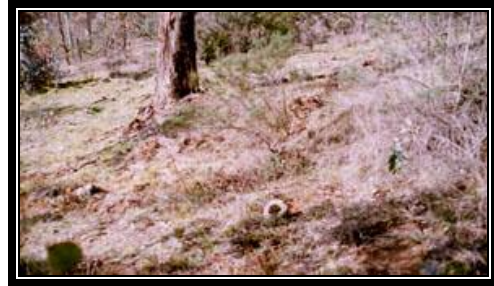
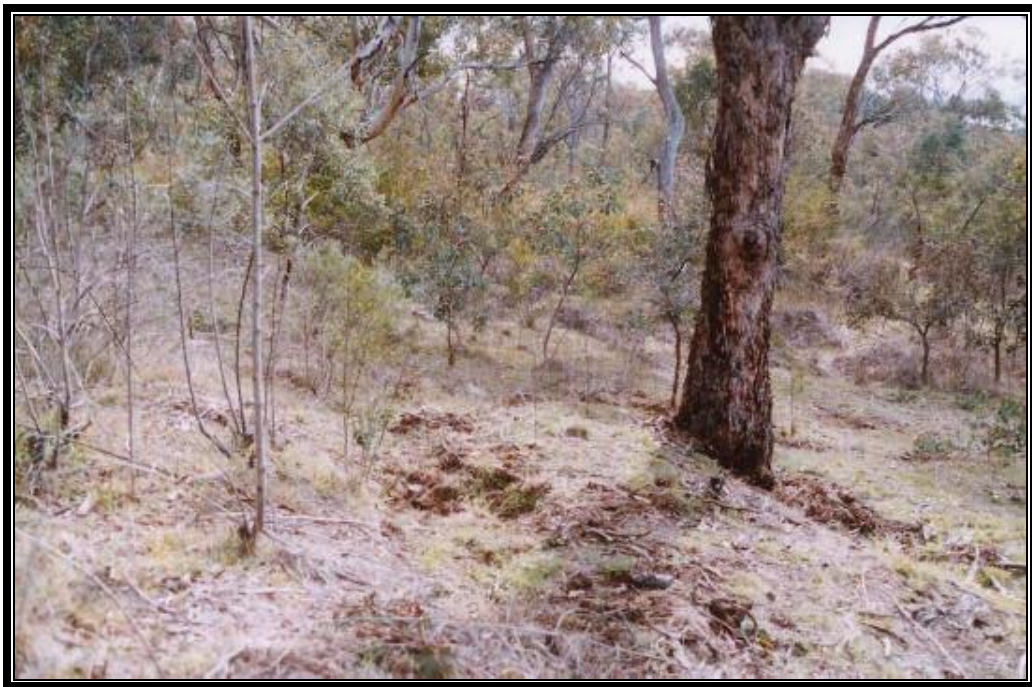
Above - view from the western side of the trench and terraces. The quagmire is in the background of the photograph. In the trench is one of two 13 circular stone bed. The other is above the trench on the quagmire side. Below left example of the small stones on the terrace above the trench. These stones are also in the big drain cut across the flat land below the tree line. On the right is a view from the quagmire side looking towards the trench area to the right of the tree.

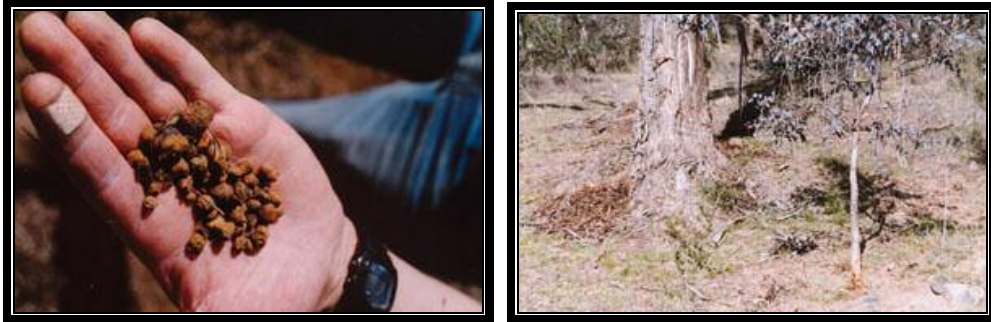
Below left are pebbles from the big drain that crosses the flat land in front of Lotus Bay. Similar pebbles were dug from the trench - site behind the tree in photograph on the right.

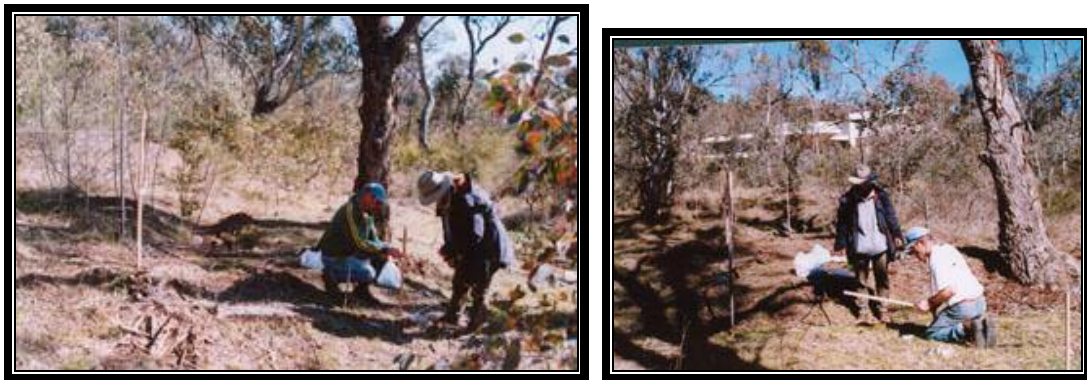
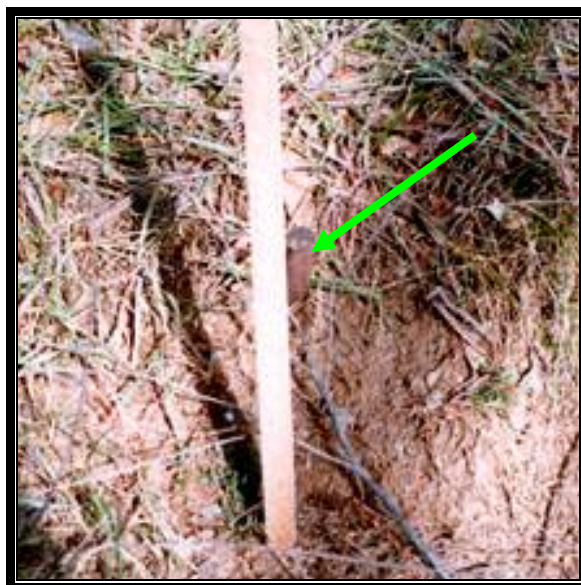
Two views below showing Karen Williams and John Bruggeman in the vicinity of the trench. In the background on the photograph on the right is the Brazilian Embassy in Forster Crescent.

Above timber marker placed in a hole that has in it a metal peg.

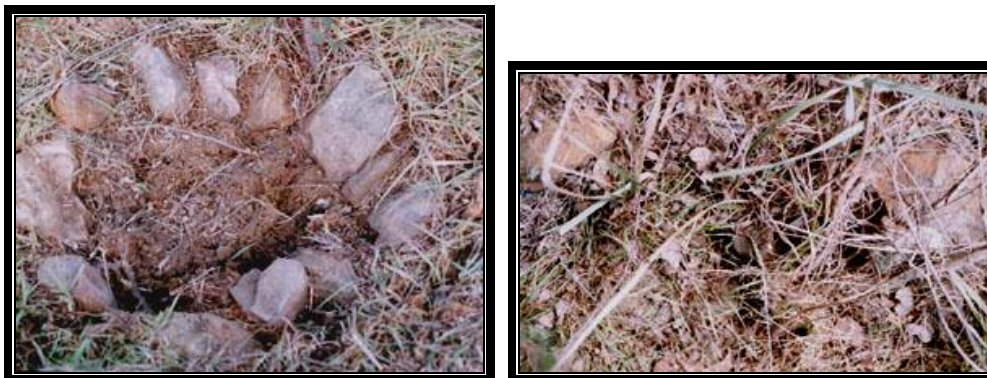
Below left sump stones in trench and right sump stones in drain above the pipe. Thirteen perimeter stones in each.

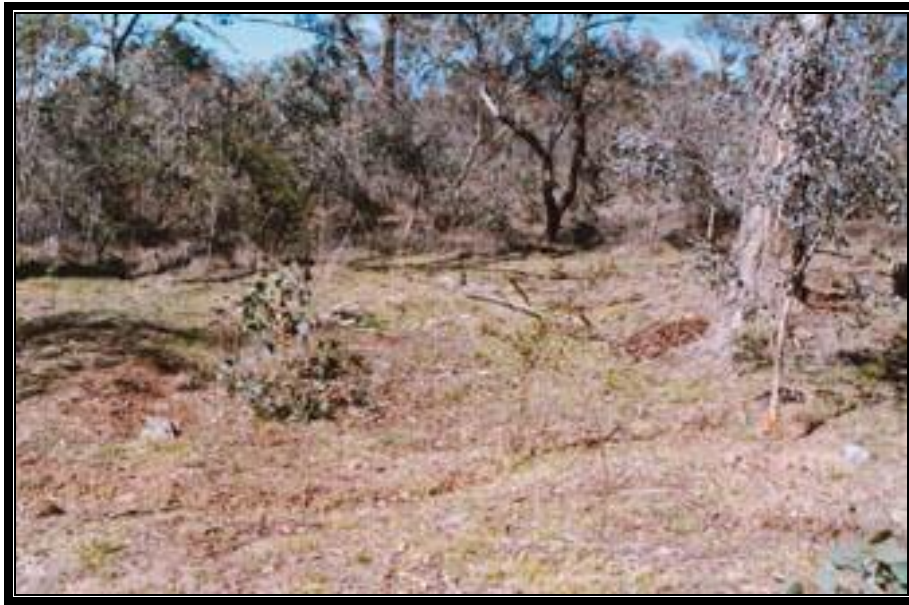
Above side view of trench area with area of drain shown. It leads down to the *saucepan* circular garden bed.

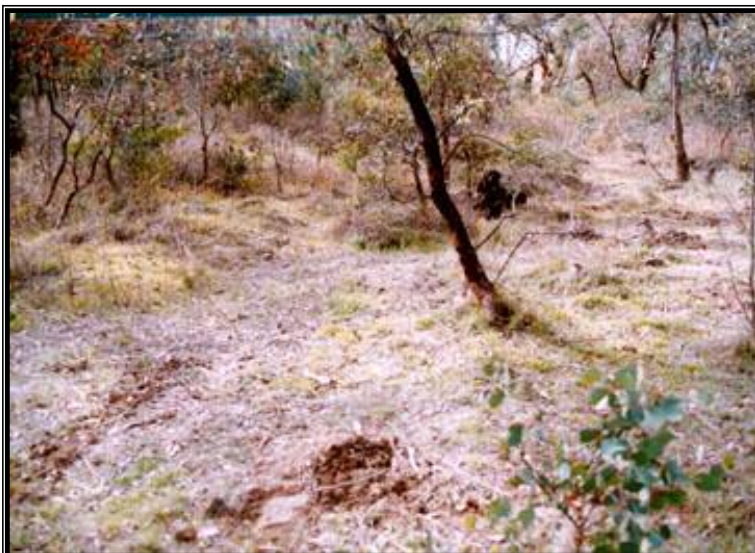
The next series of photographs show the undulating line of rocks set on the edge of earth embankment below the trench area. This area contains a number of river rocks that have been deliberately placed in the arrangement. One, a small black flattened rock and another white rock appear to have been used for decoration. The rock arrangements on the lower side of the old road near a building have a similar signature of rocks.

The photograph left shows the drain to the quagmire that directs water on that side from above the area of the undulating rocks - shown middle bottom section of the page. In the background are my two patient large Rottweiler dogs.

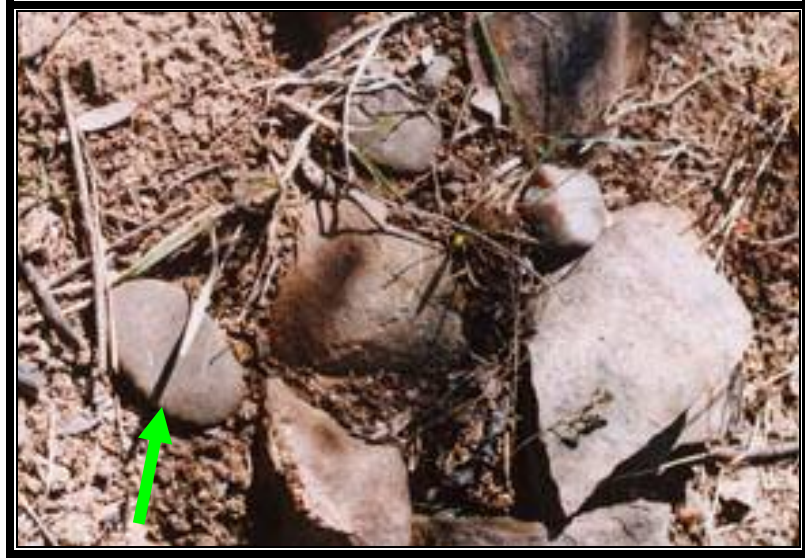
Above – arrow points to river rock in the pattern.

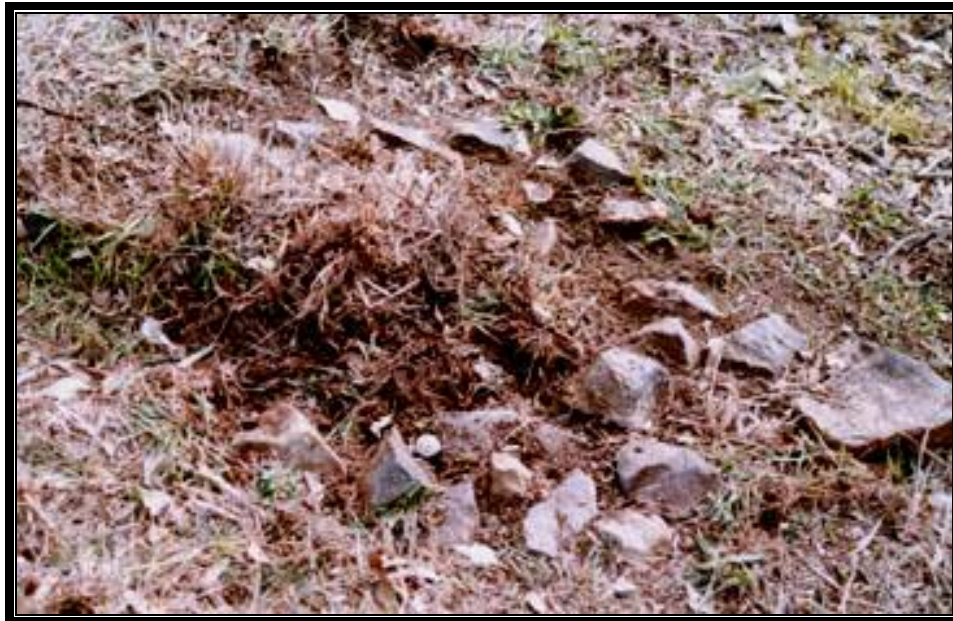
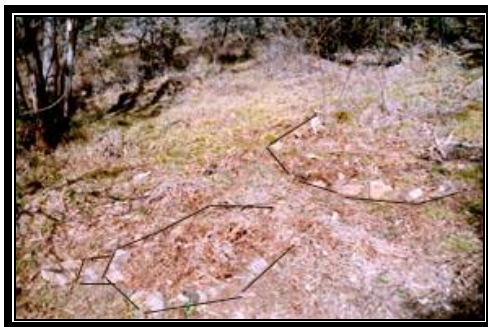
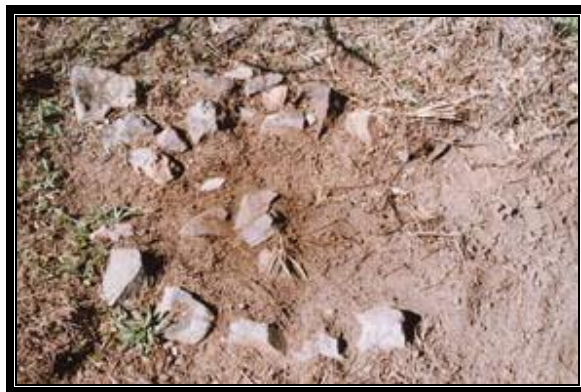
These patterns are not garden beds.

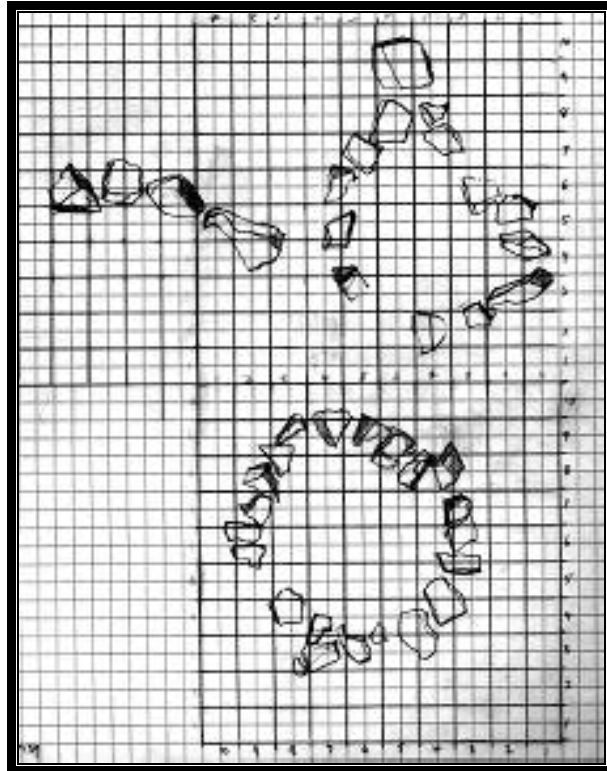
One of Karen William's drawings of the stone arrangement near the old road is shown in the next diagram. A photograph showing the grid system used to define the stone area follows.
