**WESTLAKE SEPTIC TANKS CONTINUED  
PART TWO  
THE TANK 'TODAY' & HISTORICAL BACKGROUND OF THE SEWER WORK**

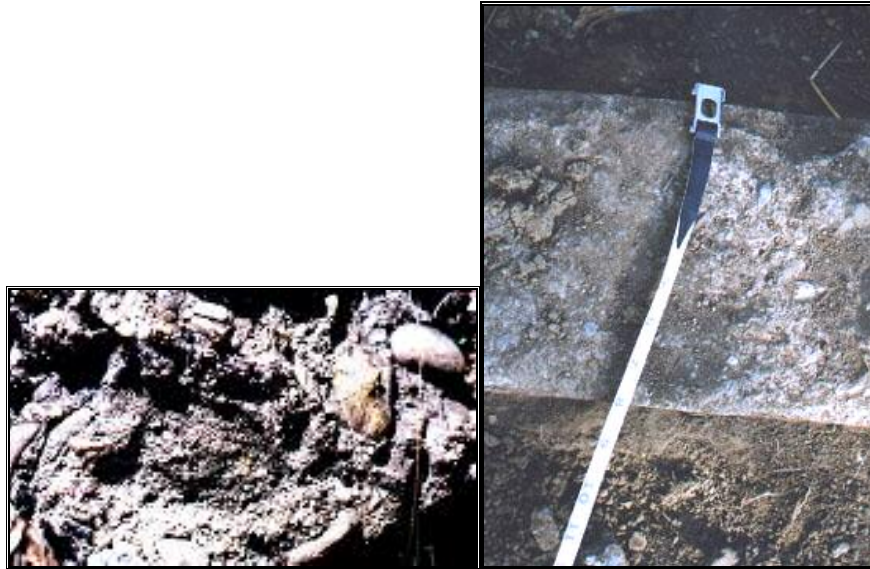
The outside walls of the tank vary in width from around 6 to 8 inches. The tank when in use had a concrete lid. Nearby in Haines Creek there are a few broken slabs of concrete that may have been part of the original lid. The concrete was mixed with river rocks (above left) and below is a detail of the end section of the tank. The top section has the indents of the corrugated iron lid that may have formed part of an inspection hole. Still embedded in the concrete are small pieces of rusted iron.

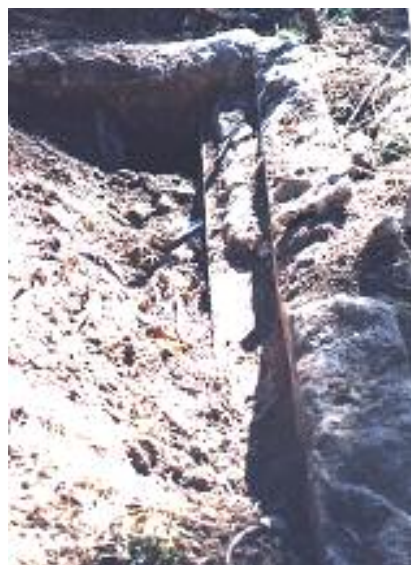
Below are details of this section of the wall. On the lake end of the tank on the left side the concrete on the shelf has taken the shape of corrugated iron. The iron has rusted away leaving only its impressions behind.

The corrugated iron sheet measured from the left hand corner two feet six inches across. The area that surrounds the tank is now filled with the rubbish of years. However in the area near the corrugated iron on the outside a shallow depression in the earth suggest that an overflow section may have been there.

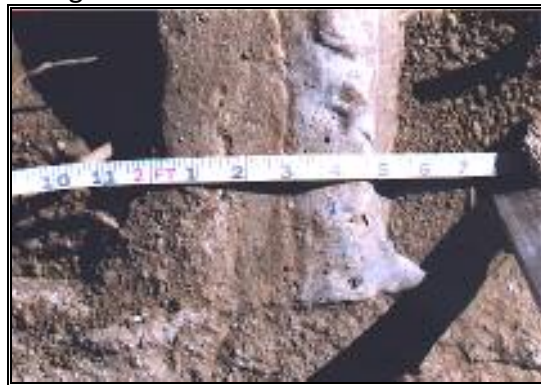
Below: Lead still in situ on one of the middle dividing walls.

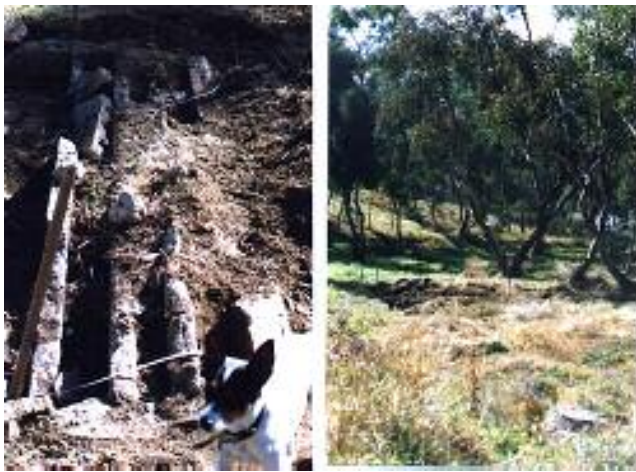
Some preliminary work has been carried out on the surviving tank at Westlake. The tank consisted of two large rectangular spaces divided by a series of smaller walls. Each wall in the centre is around 4 inches in width and the spaces between are approximately six inches, three inches and six inches. One had a ledge lined with lead. The outside walls of the tank range in width between six and eight inches. The total length of the tank is twenty-two feet, ten inches and it is in square. This was a rough job because one would expect the walls to be of a consistent thickness and in multiples of 4. I would have expected the length to be twenty four feet. It is around eight feet across. To date the depth is not known because it has not been dug out. However, Hazel Kennedy (nee Haines) of Westlake recalled playing in the then empty concrete tank in the 1940s. It had a concrete lid and was from her memory around six to eight feet deep.

Walking in the area of the tank today is difficult because of the uneven lie of the land caused by recent works and rubbish now covered with thick growth of grasses through

which briar roses, daffodils and other bulbs protrude and flower in the spring months. Haines Creek was used for the overflow from the septic tanks and a place to throw rubbish. Hidden amongst the undergrowth also are a number of exposed pipes that connected cottages to the septic tank.

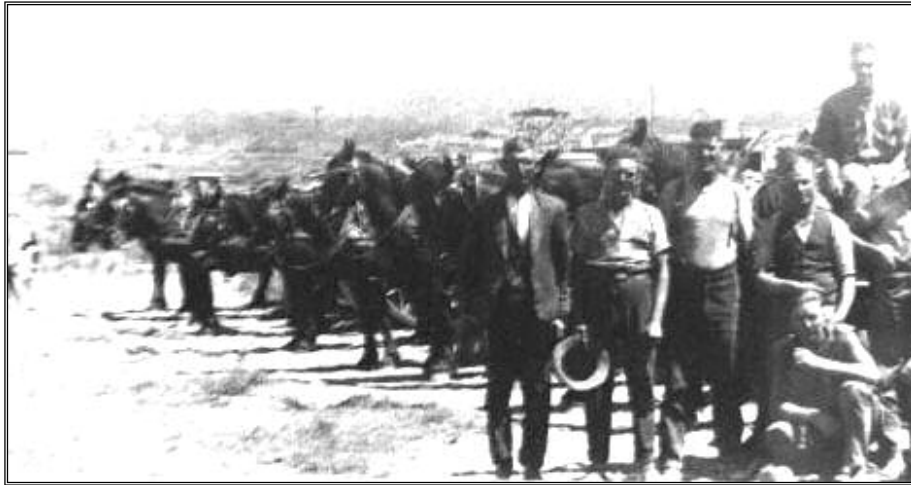
Left is a photograph of the sewer men. In the background is Red Hill and the buildings just discernable on the right above the men's heads is the Hotel

Canberra – 1925. This photograph was loaned by Marjie Rundle (nee Hawke) who lived at Westlake. Her father and grandfather worked on the sewer.

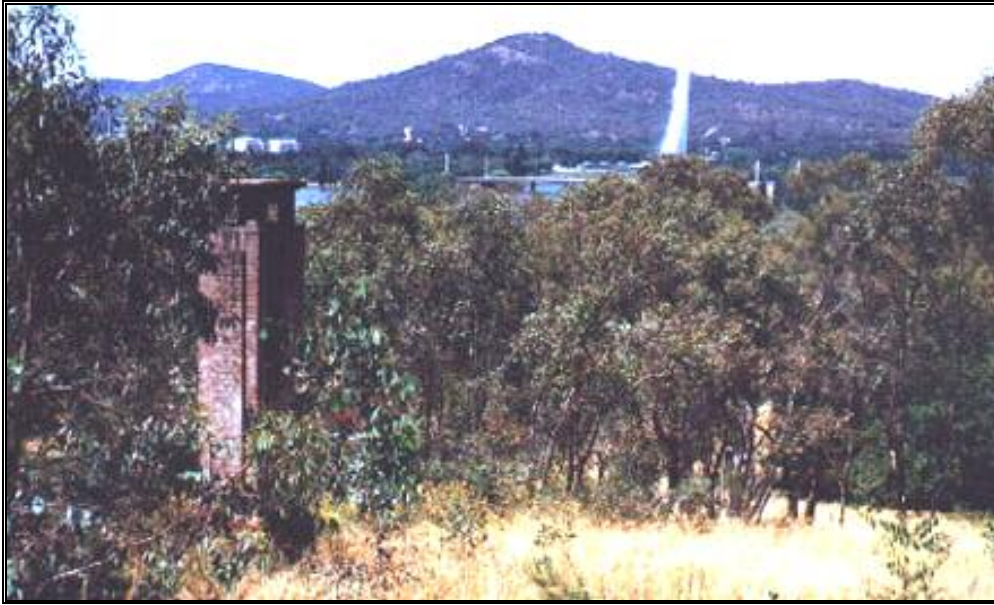
Above is the sewer vent on Stirling Ridge. It is still known to most Westlake people as *The Chimney*. It still brings to the surface the pungent odours of methane gas and during the 1930s was blamed for an outbreak of a childhood disease. Upon inspection it was discovered that children had managed to get the lid off the nearby manhole and had made an attempt to fill the tunnel at that point with rocks. Once cleared the flow went back to normal and the stink lessened. Nearby to the vent was one of two mullock dumps left over from sewer work. It like the one between cottages 28 and 53 has now been spread out over the hillside. Both were always referred to as *The Dump*. The above view taken in the late 1990s looking out towards the city of Canberra has in the background Mount Ainslie. Below Right: Ilma Keir standing outside 31 Westlake. In the background is one of the two mullock *Dumps* at Westlake.
