**The Westlake Septic Tanks (1924-1927)  
& Sewer System  
(Sewer constructed at Westlake between 1922-25 at  
Westlake & used there 1927-1965)<sup>1</sup>**

**The Septic Tanks**

### **The Remaining Westlake Septic Tank**

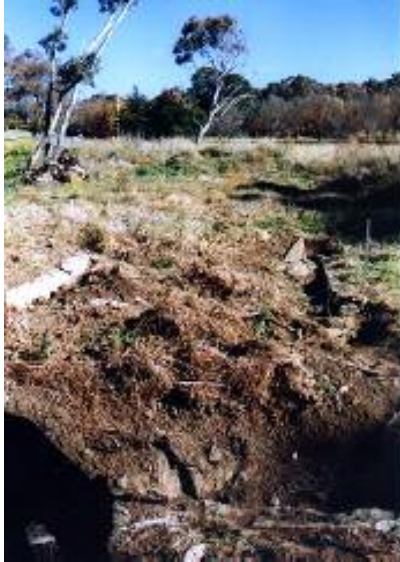
Photograph taken in 2000 of the remaining septic tank in Stirling Park. Part of the walls show. The view looks towards Forster Crescent. The gum tree in the middle was near the front entrance of 52 Westlake. On the next page is a plan of the Septic Tanks of the type used in the 1920s. Below is an example of plans for septic tanks circa 1926.

Midway between the ditch dug across the hillside below cottages 43 to 47 and near the point where it joins Haines Creek is the third septic tank not mentioned by Mr Fraser. The finding of this surviving Westlake septic tank came about by accident during a woody weed clearance in the park in the early 1990s. Heavy vehicle activity in the area flattened grass and exposed parts of the reinforced concrete walls of the rectangular

shaped tank. It has two large rectangular receptacles separated by a number of close thin walled spaces. River rocks were used for reinforcing.
